TREASURES OF THE ROSEAU CATHEDRAL: MURALS part 2 .

MURAL 2 : THE ENTRY INTO JERUSALEM

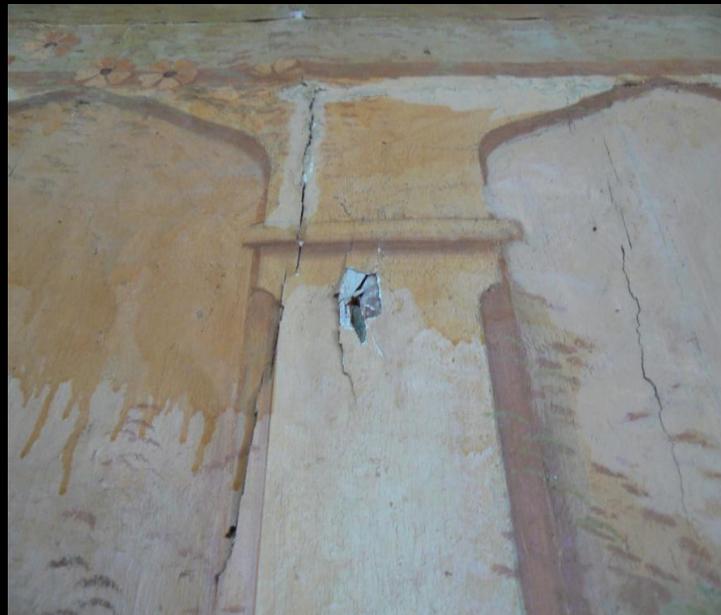
This canvas is fixed on timber boards, which poses its own problems, especially due to the size of the painting. As an organic or “living” material, timber is vulnerable to the elements in quite specific ways. Room temperature changes, fluctuations in moisture content, gravity and tremors can induce dramatic changes in the shape of the boards, especially when they are not well braced by a frame, as is the case here, or not well clamped together. The boards can split, warp, twist and bend away from the frame or canvas.

Notice the splitting of the individual boards causing vertical cracks in the canvas.

Local artist Earl ETIENNE inspected this second mural and concluded that the painting is too fragile and damaged to be moved and stored away. His recommendation is to box the painting up with plywood, protect it from the rain with a small roof and from condensation with brown paper and ventilators. Once the roof works are finished, he will have a huge task to restore the painting.

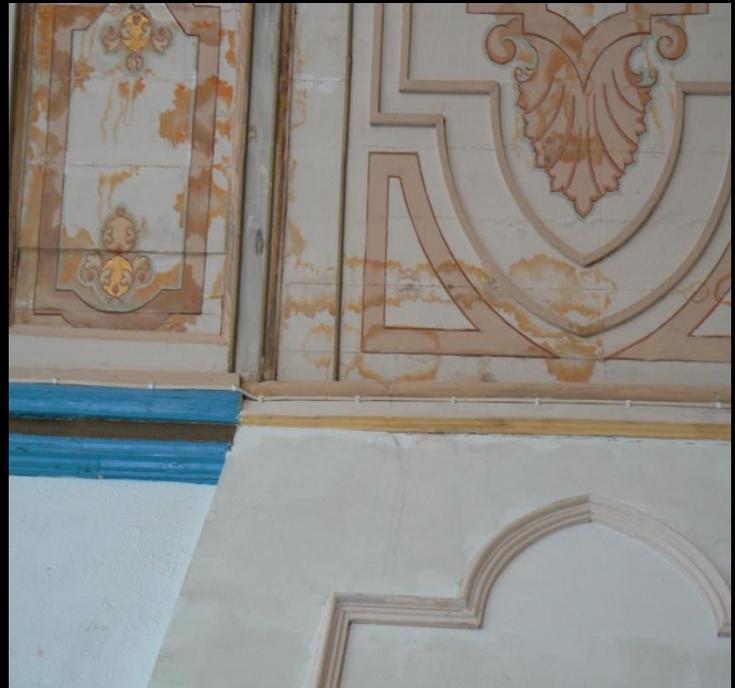
1. Several signs of water damage due to leaking roof valleys:

The paint is discoloured, blistered and flaked. There is mould around the affected area. The reaction to the water deteriorated the fabric of the painting and caused de-lamination of the painting from the canvas. The back of the canvas is most vulnerable.

Water damage causing WET ROT to the boards and moulding strips. The timber support of the canvas is no longer solid.

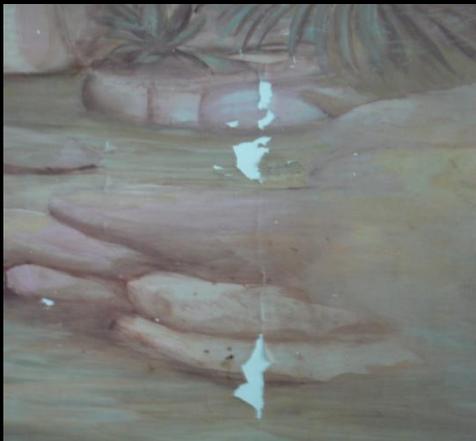
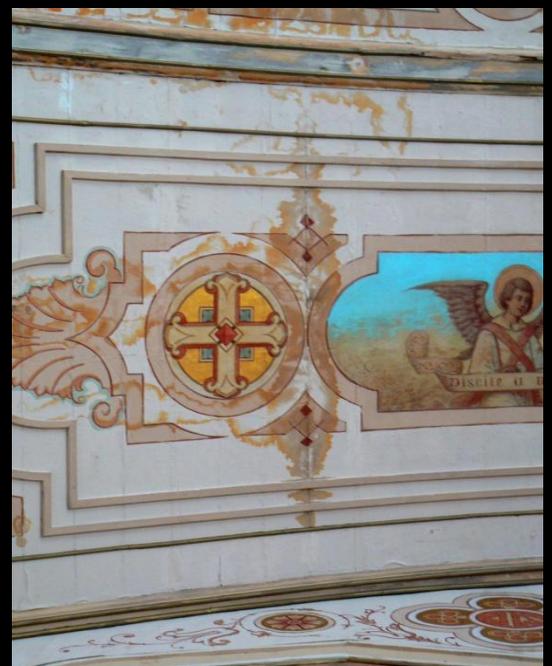
2. “Craquelure” is the technical name for cracking; the single most obvious sign of old age in an oil painting. It is a French term to refer to the cracks, visible when the surface of the paint literally separates from the base, revealing the white ground colour beneath.

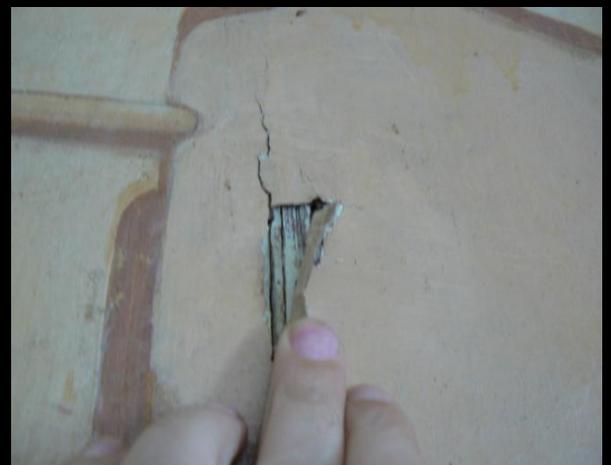
3. Torn canvas exposing cracked timber backing.
