THE ROSEAU CATHEDRAL: THE CHANGES in the FRONT ELEVATION after hurricane DAVID 1979.

By Bernard Lauwyck

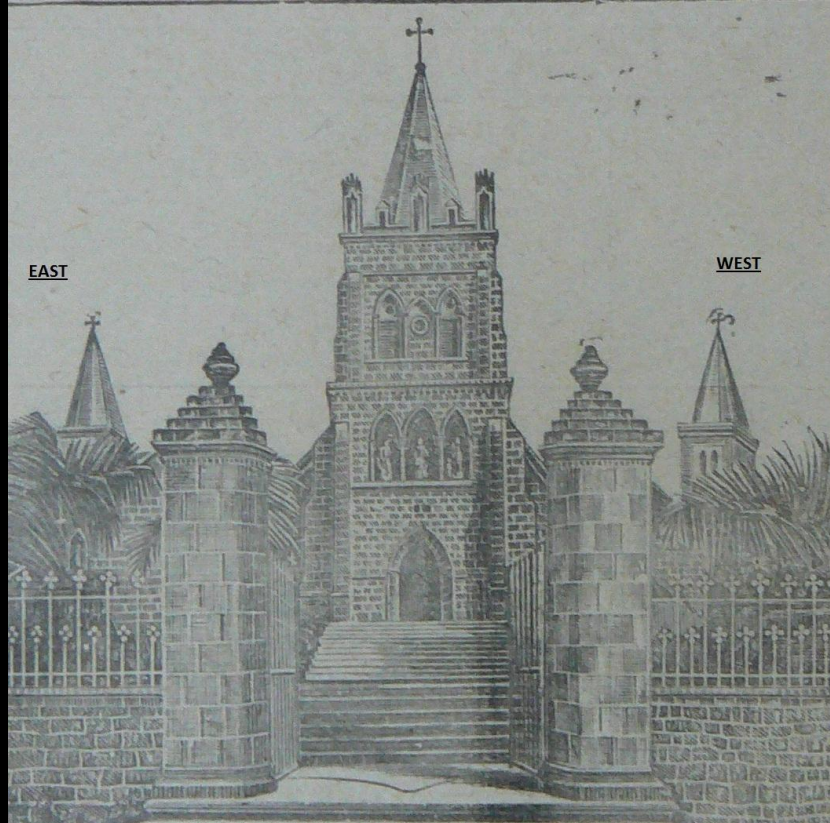
As we mentioned before the eastern spire fell on and through the roof of the side aisle. The two round stained glass windows in the front elevation were damaged. The statues in the front elevation are gone.

The embattled parapet of the tower of Roseau used to have 8 merlons , three on each face as can be seen on the photograph.

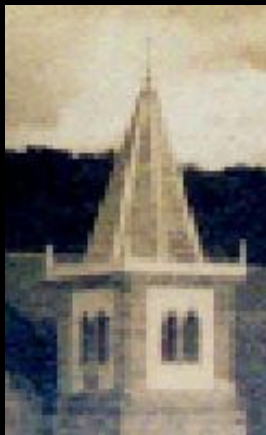
2. the east and west spires became domes.

The collapse of the East spire, created a discussion between rev. Fr. Charles Vermeulen and visiting Brother Jacob C.S.s.R. about the advisability to reconstruct a spire. Also the west spire showed signs of weakness. Mr. Guy Steenput, Belgian architect assisting Fr. Charles with his reconstruction efforts from May 1980 till 1982, designed a dome for the two side towers. This was accepted by Fr. Charles but was constructed, in reinforced concrete, to smaller scale by Brother Jacob and Mr. Augustus Parker. The concrete was covered by Brother Jacob with a blue polyester coating. Two ornate steel crosses were placed at the apex of the two domes.

However as the years went on, we have grown accustomed to the domes. In the Project Management Committee of the Roseau Renovation Project, voices were raised to restore the two small spires during the renovation project and this hope might become a reality, if funds are available.

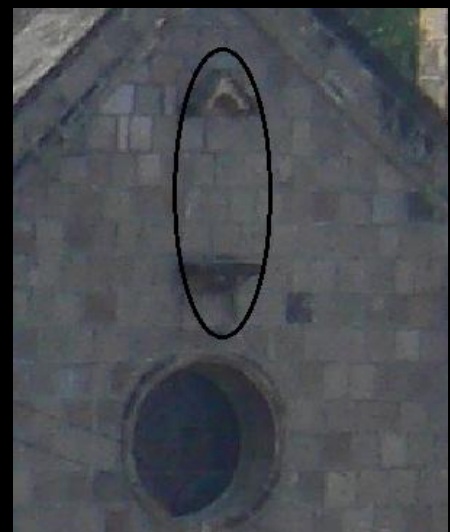
3. The two statues above the side entrances

According to my information there was one statue of St. George, the patron of the civil parish of St. George above the western side of the facade. And one statue on the eastern side, now also disappeared. If anyone can help me with this?
